# Case studies in engineering and ethical failures

Craig A. Wallace, P.Eng.

CIVL 402

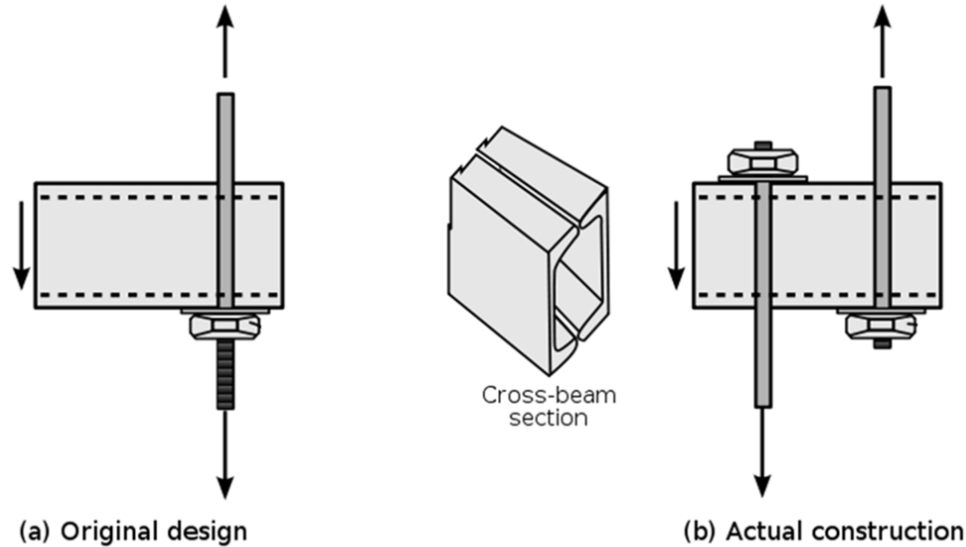
Design change suggested by contractor during construction for ease of fabrication.

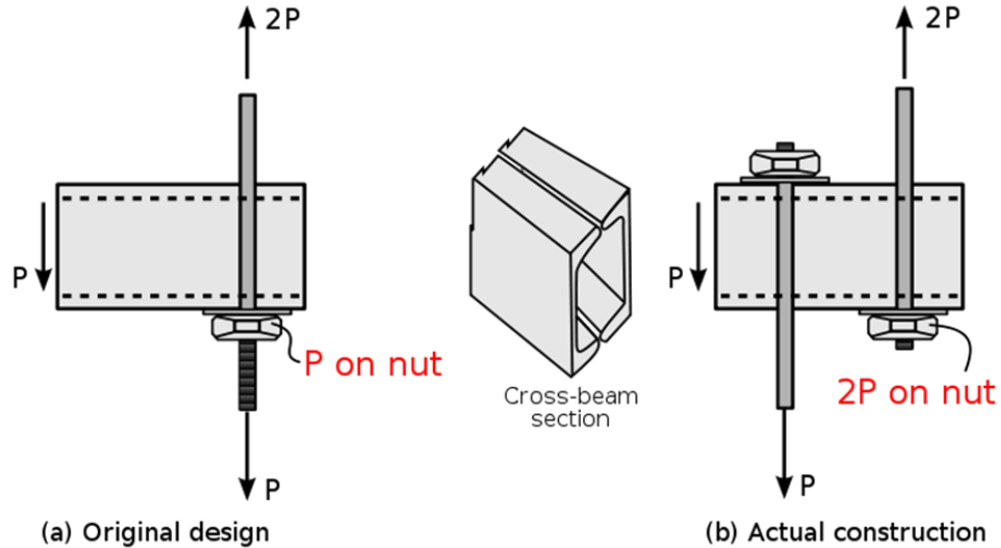
- The result was that the load on the nuts holding the fourth-floor walkway doubled, with tragic results.
- As a result of various hearings and lawsuits, several engineers lost their licenses, firms went bankrupt, and lives were ruined.

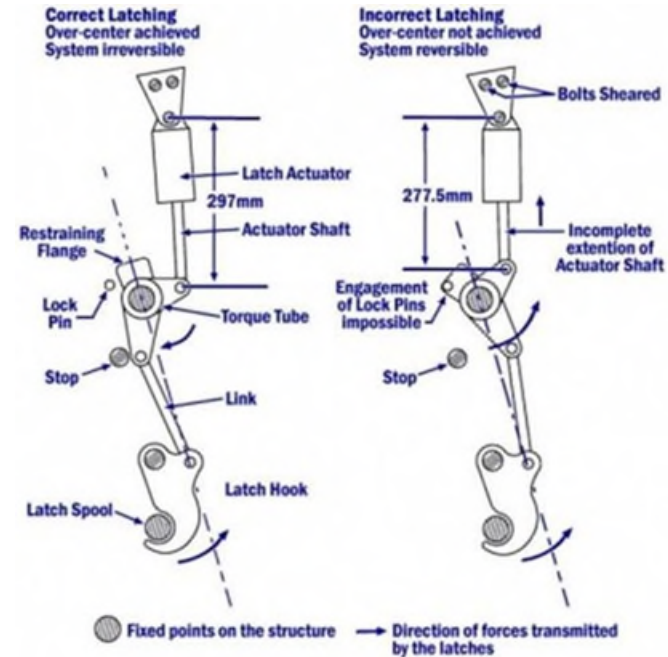
- Passenger doors are "plug type" (inward-opening) – pressure prevents door from opening.
- Cargo doors have to open outward, but pressure would assist in keeping the latches closed.
- Incomplete closure would result in pressure forcing the latches open.

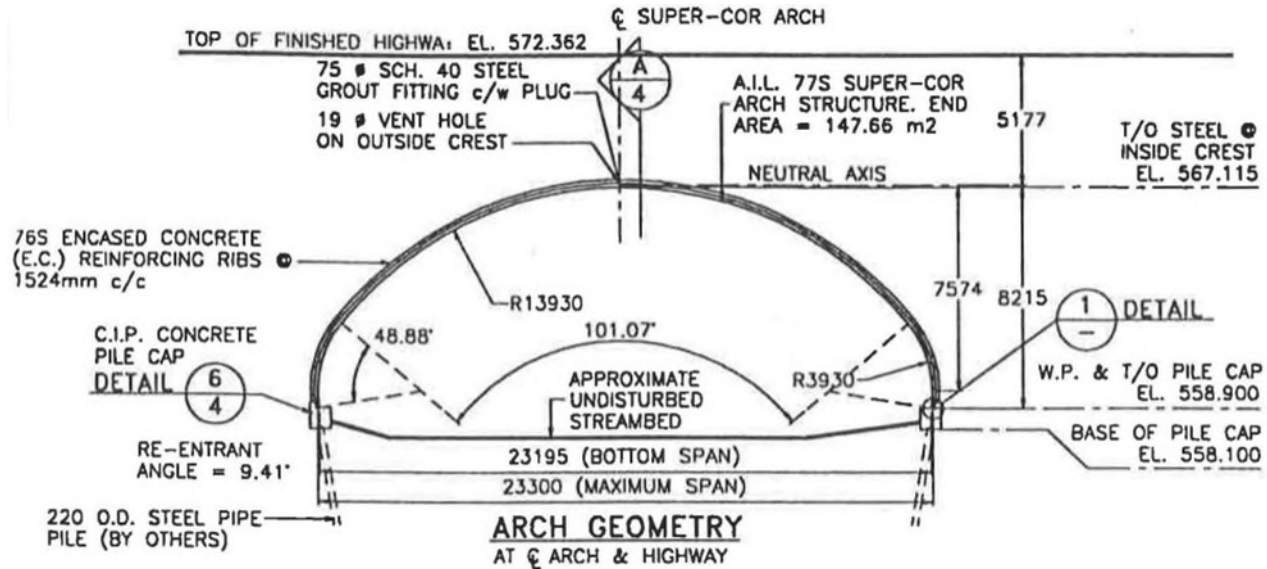
Culvert engineer's quote said that owner's or contractor's engineer must check for scour.

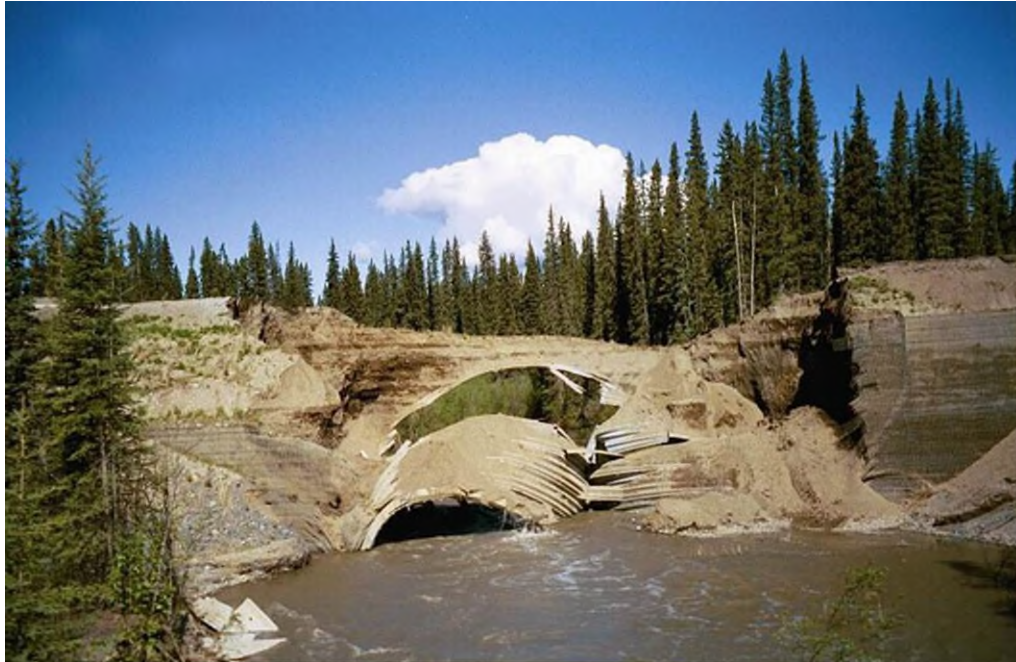
- Pile designer never saw the culvert engineer's quote.
- Pile designer had no expertise in "scour" and was only asked to design the piles.
- Design-build contractor ignored the warning on the quote and did not hire anyone to look at scour - ( A hydrogeomorphologist).
- Construction proceeded without anyone examining the impact of scour.
